EPA Observations on Plum Island Building 257

On June 18, 2018, representatives from EPA's Office of Land and Emergency Management's CBRN Consequence Management Advisory Division (CMAD) and Office of Research and Development's National Homeland Security Research Center (NHSRC) accompanied representatives of New York State Department of Environmental Conservation (NYSDEC) on a visit to Building 257 at the Plum Island Animal Disease Center (PIADC). The purpose of the visit was to view Building 257 (see Figure 1) in its current state so that recommendations could be made to the Department of Homeland Security (DHS), who operates the PIADC, and NYSDEC on potential options for releasing the building for sale.

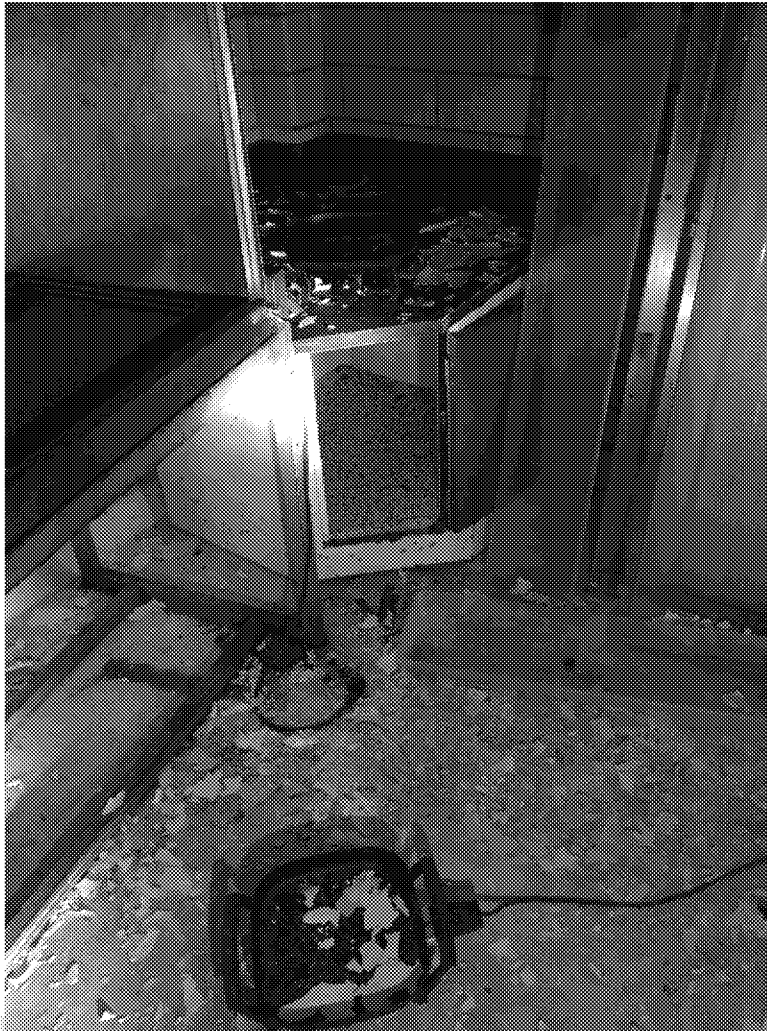
Building 257 had been used in the past to carry out animal disease research, using a variety of viral agents as well as some vegetative bacteria. No spore-forming bacteria (e.g., *Bacillus anthracis*) had reportedly been used in the building. The building has remained unused since the late 1990s, when it was decontaminated using diluted bleach (1:10 household bleach) on horizontal surfaces only. A fumigation with formaldehyde was planned, but never executed. The electric frying pans and electrical drop cords from the not-performed formaldehyde fumigation were spread throughout the building (see Figure 2).

Figure 2. Electric Frypan Deployed for Formaldehyde Fumigation

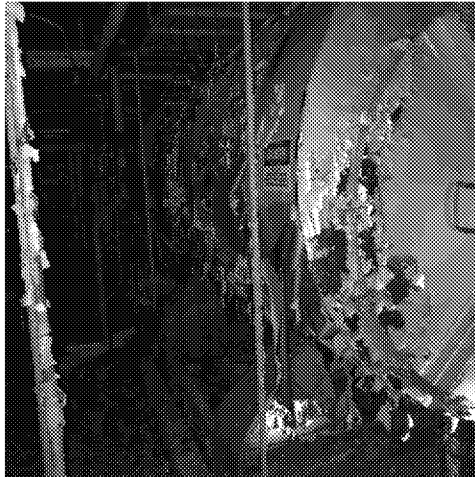
The building appears to be more or less in the state it was when it was abandoned in the late 1990s, with the addition of 20 years of aging on the various surfaces. Although it appears that most papers and small laboratory equipment were removed, larger equipment (e.g., tables, autoclaves, boilers) appears to have been abandoned in place (see Figure 3). The floors appear to be mostly unpainted concrete. It is not known whether the concrete was sealed. There were a number of animal prep rooms that appeared to have either painted or epoxy-coated floors (see Figure 4). The paint (possibly lead-containing) on virtually every vertical and horizontal painted surface seems to be compromised (see Figures 5 and 6). The floors that were made from vinyl tile (possibly containing asbestos) were characterized by the edges of the tile lifting from the floor underneath (see Figure 7).

Figure 3. Abandoned Boiler

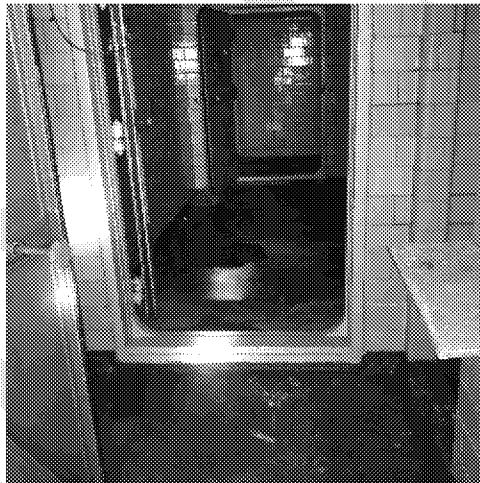
surfaces in the animal prep rooms would be amenable to surface sampling using swabs, vacuums, or sponge sticks.

Figure 4. Animal Prep Room

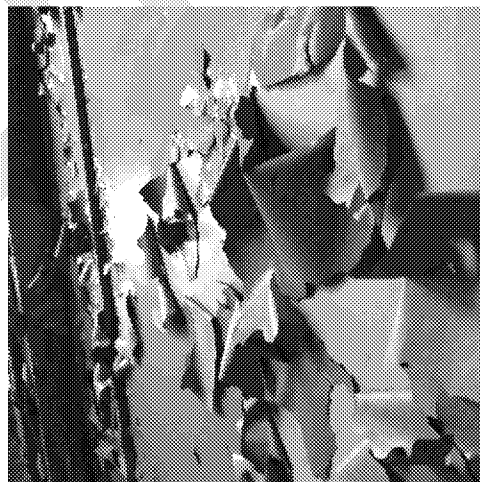
The compromised nature of the paint would make it problematic to perform surface decontamination operations due to difficulties in assuring wetting of the surfaces and the huge mess that would be generated by flaking paint being dislodged with even the gentlest force being applied to the surfaces. Acquiring reliable surface samples might also be difficult due to the condition of the paint, although the

Figure 5. Compromised paint on Vertical Surface

No matter what is done relative to the bio concerns, the NY property transfer requirements for sites potentially contaminated with hazardous materials will need to be complied with. Specifically, the lead-based paint and asbestos issues will need to be addressed regardless of what bio option is selected. Addressing the lead and asbestos issues may complicate the bio options. Additionally, in real-estate property transfer the outside soils may also have to be evaluated. Occasionally limited use deed restrictions are a component of reuse and that deed restriction would impact the risk receptors.

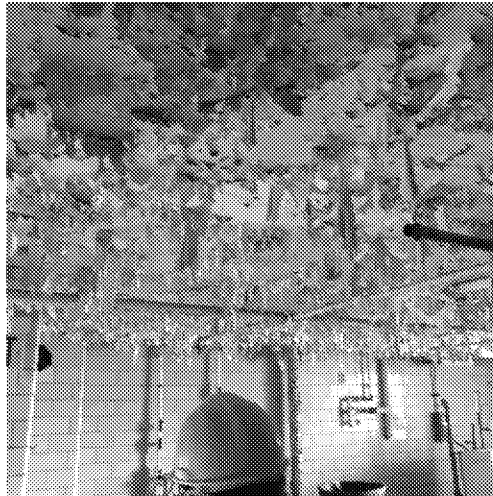
Figure 6. Compromised Paint on Horizontal Surface

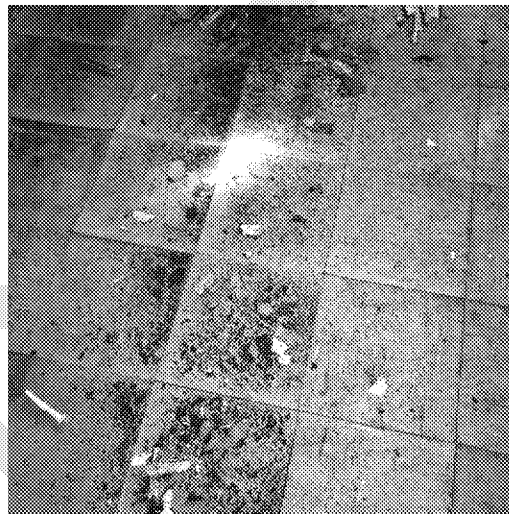
Figure 7. Tile Floor Edges Peeling
